HAMILTON ROAD SECTION

PACIFIC POWER

DEL NORTE TO YUROC
TRANSMISSION LINE

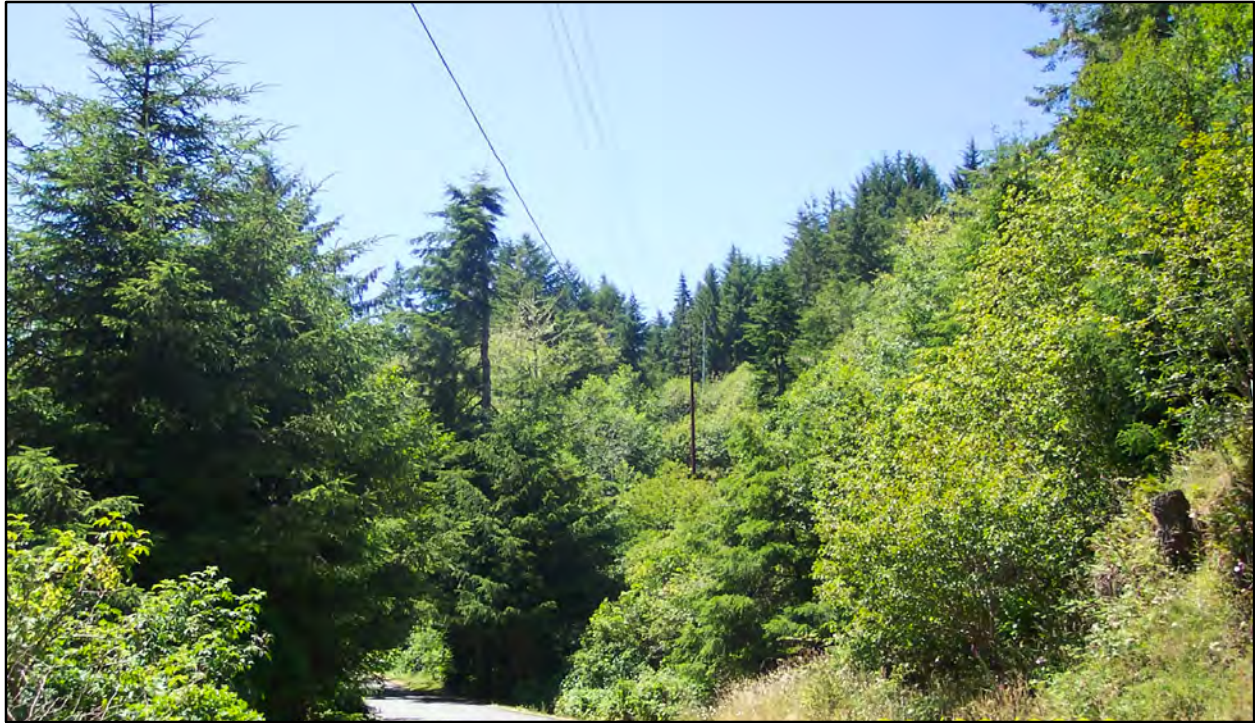
Photograph 1: Top 3 wires are the PacifiCorp line. Vegetation is growing too close.

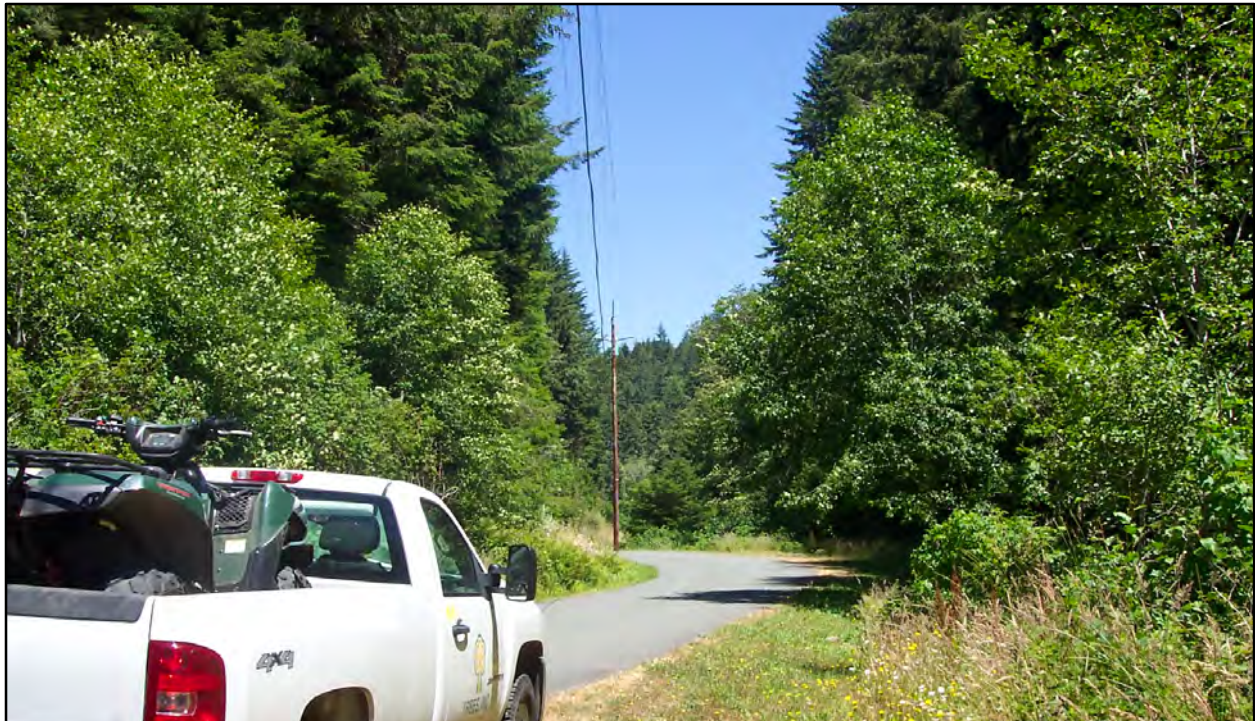
Photograph 2: Pole 8/14. On the paved access road into the Mill Creek Addition area. On the left of this photo, note the high limbs endangering the power line that need to be trimmed back.

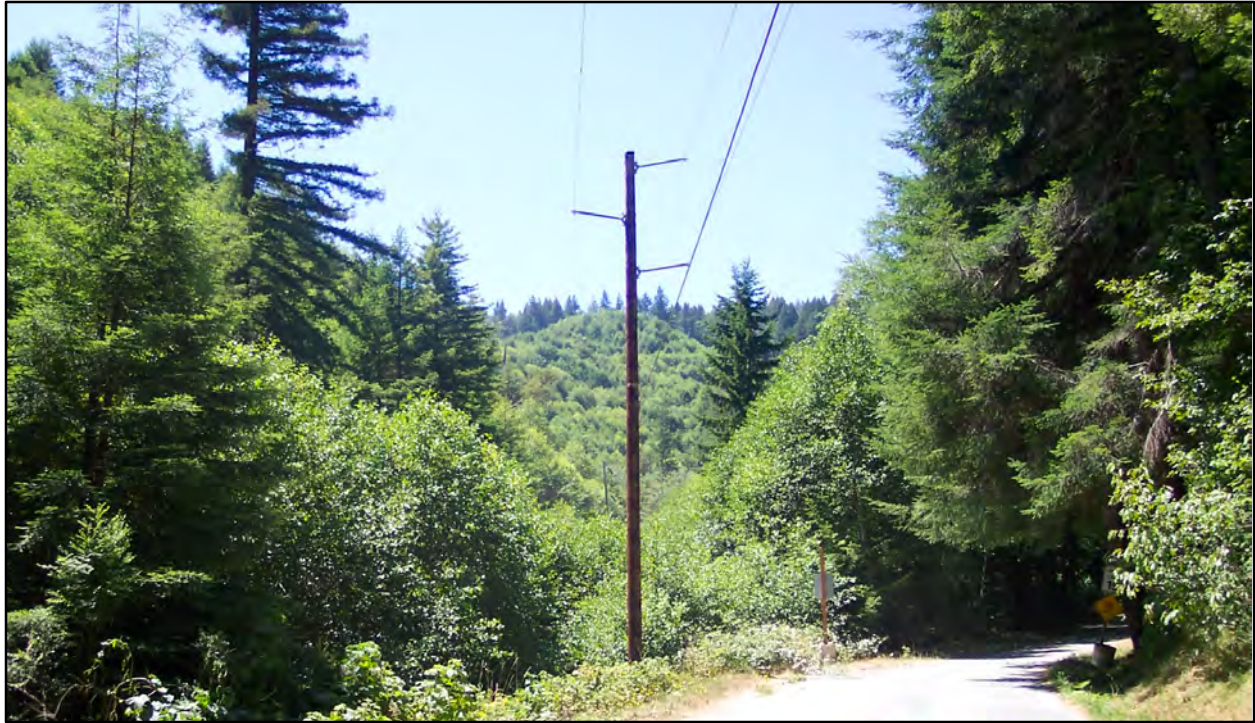
Photograph 3: Pole 7/16. This site is near the Mill Creek Bridge, and has good powerline clearance.

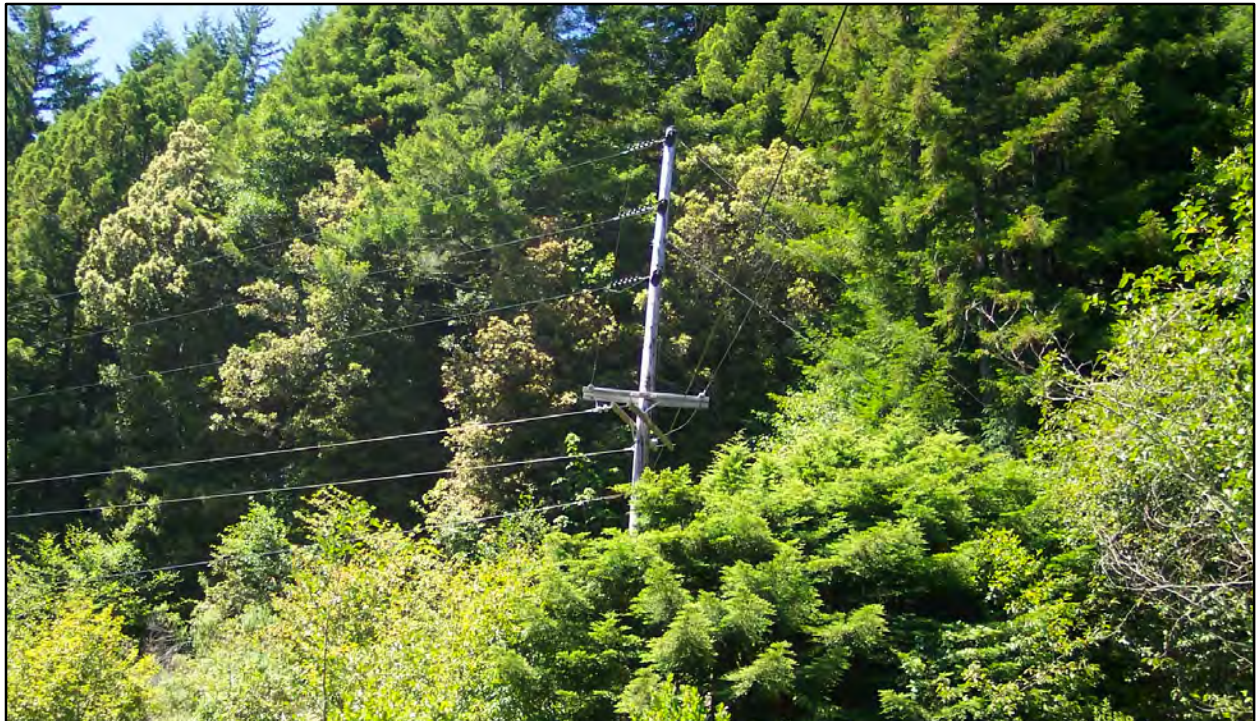
Photograph 6: Pole 13/13. Line turns to cross Hamilton Road. Note Redwood tree to right of line that needs to be topped to protect the line.

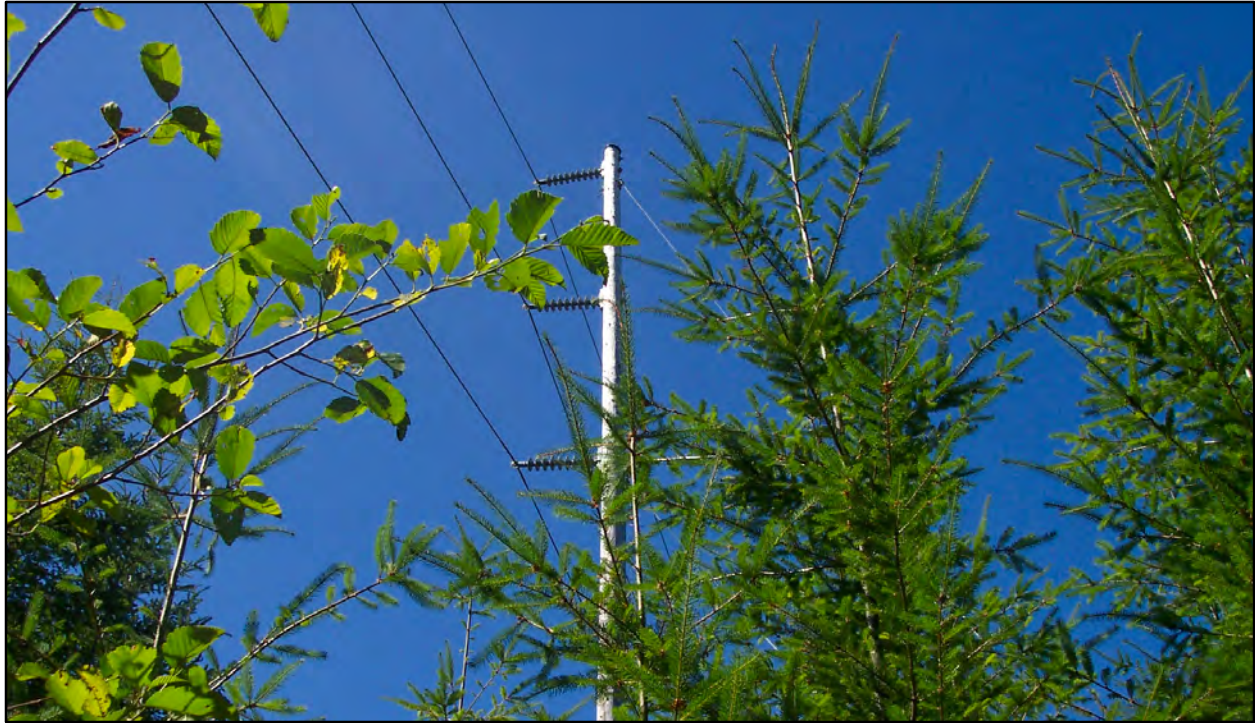
Photograph 7: Pole 2/15. Top of Moratorium Ridge. Note young fast growing trees under the power line that need to be removed.

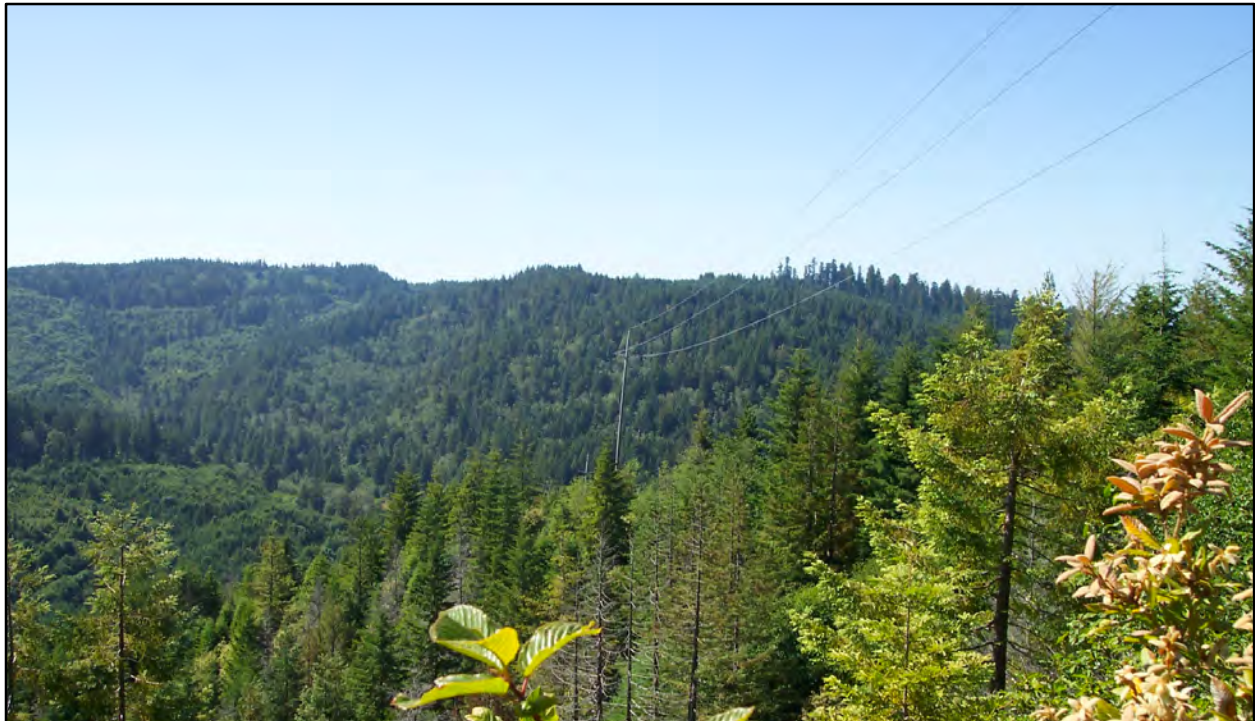
Photograph 8: Looking south from pole 3/15. Power line is clear but trees may encroach in the future.

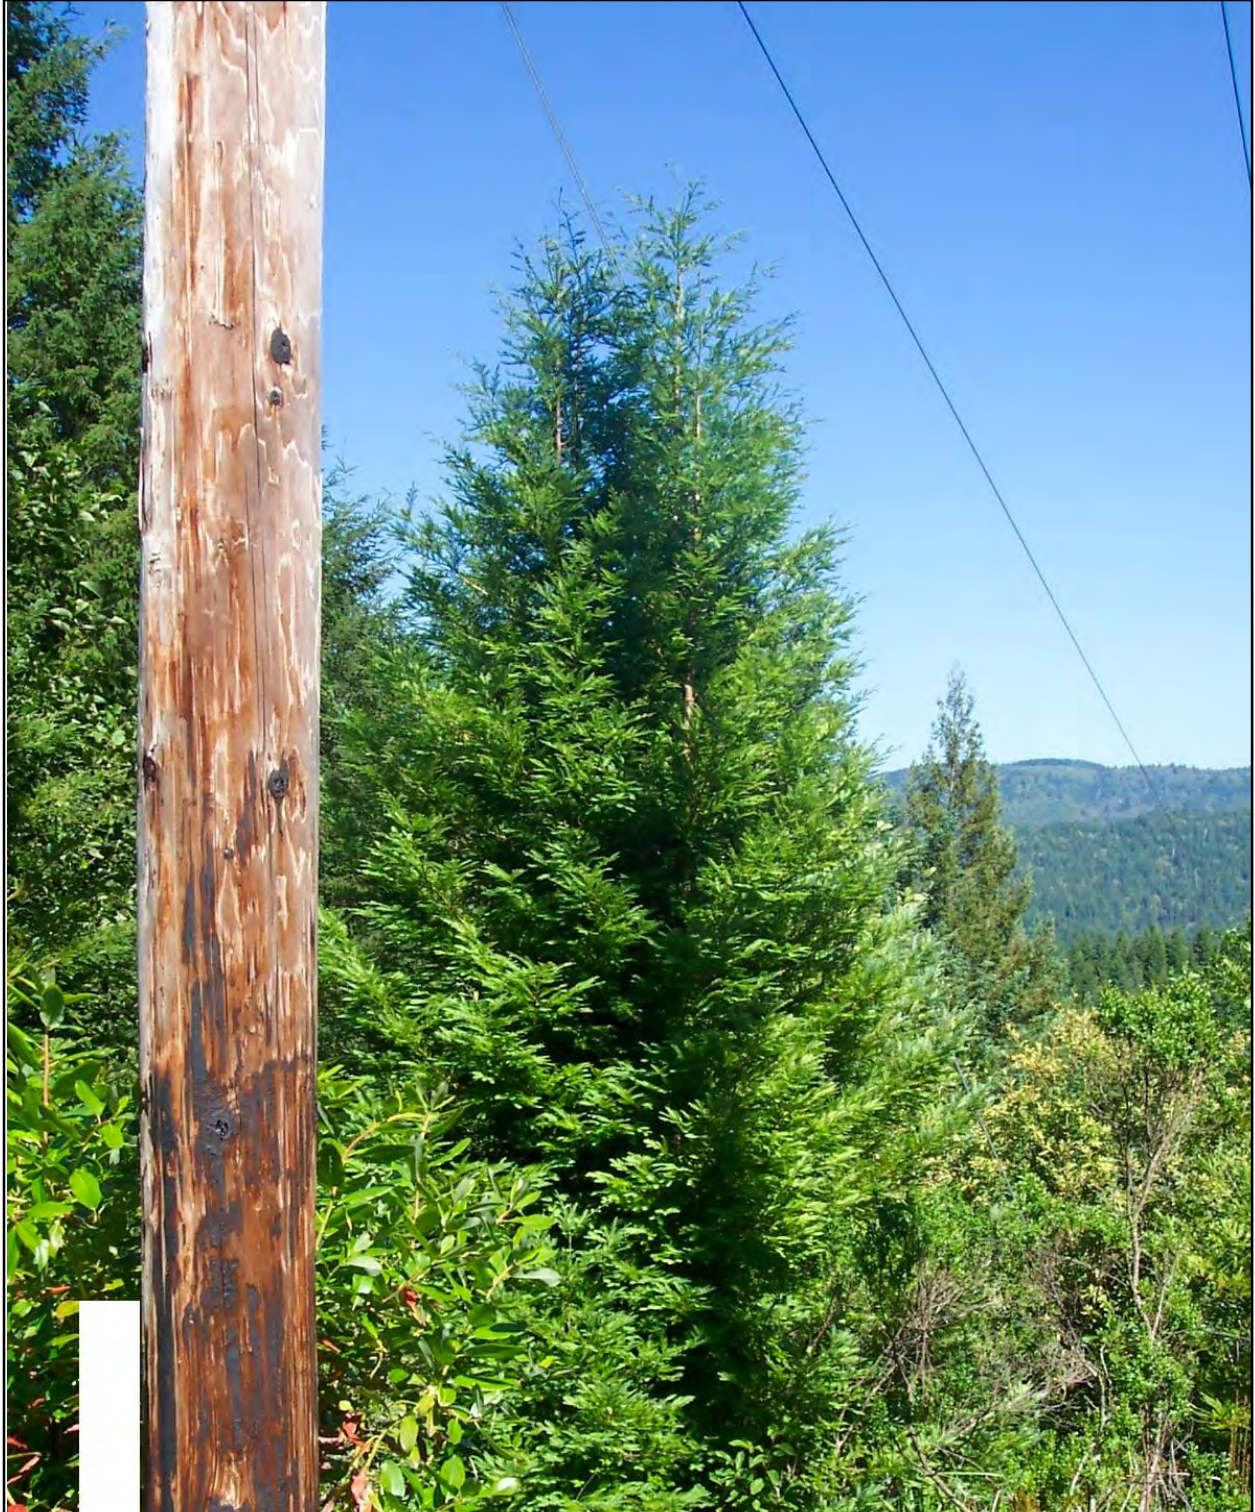
Photograph 9: Pole 12/15. Alder trees and high brush can be left in most locations at pole 2/15. Redwood less than 10 years old growing under the power line needs to be removed.

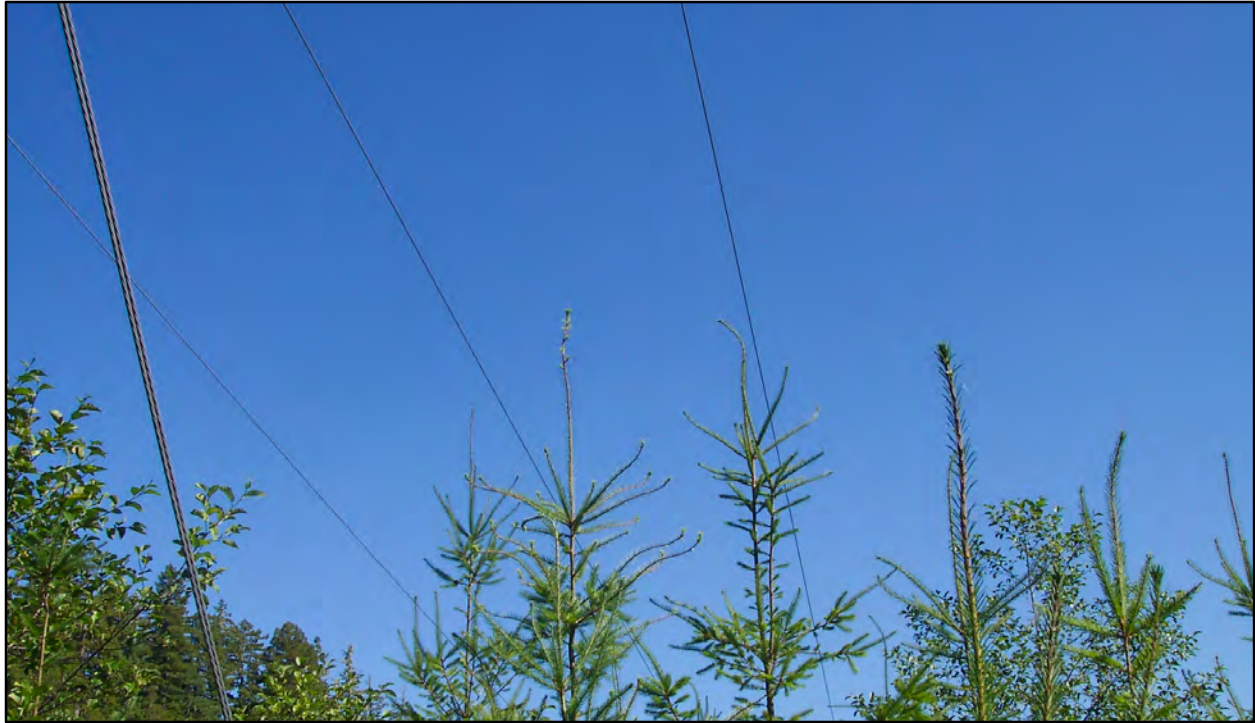
Photograph 10: Pole 4/16. Rapidly growing young trees under the line must be cut periodically. This picture is typical of conditions wherever the canopy is open.

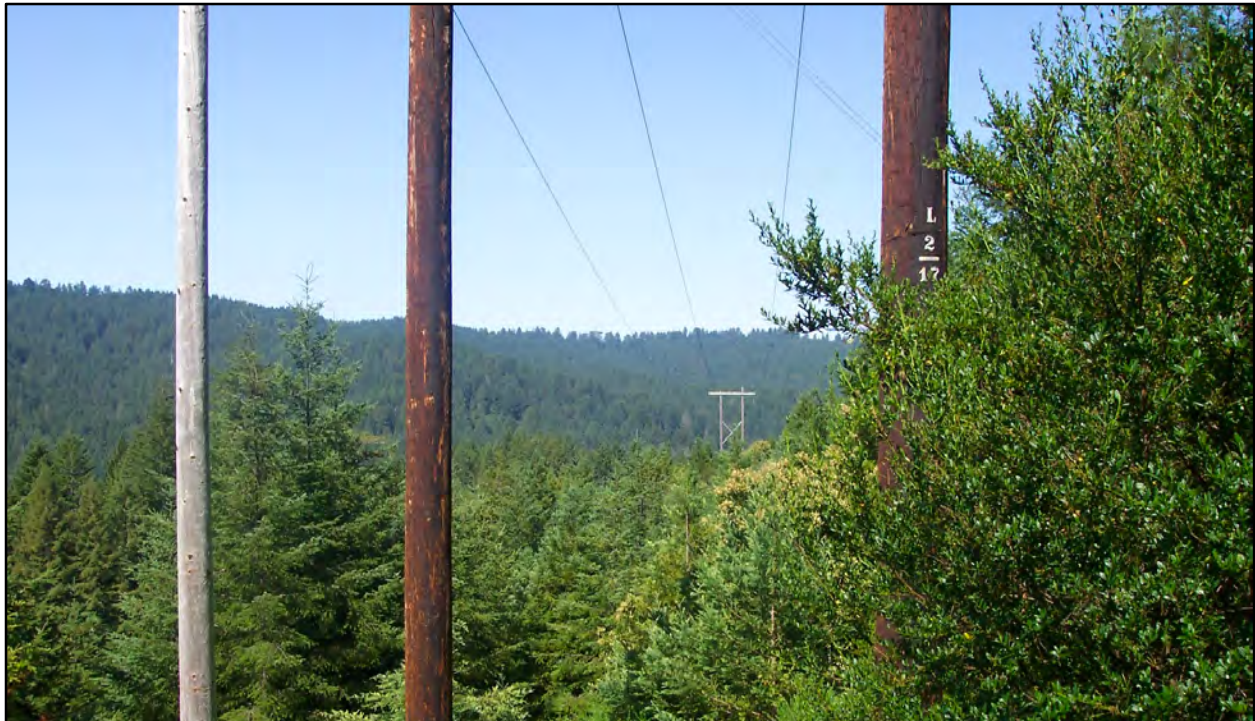
Photograph 11: Pole 2/17. There is much more clearance where the power line spans the valley and vegetation management can be less frequent.

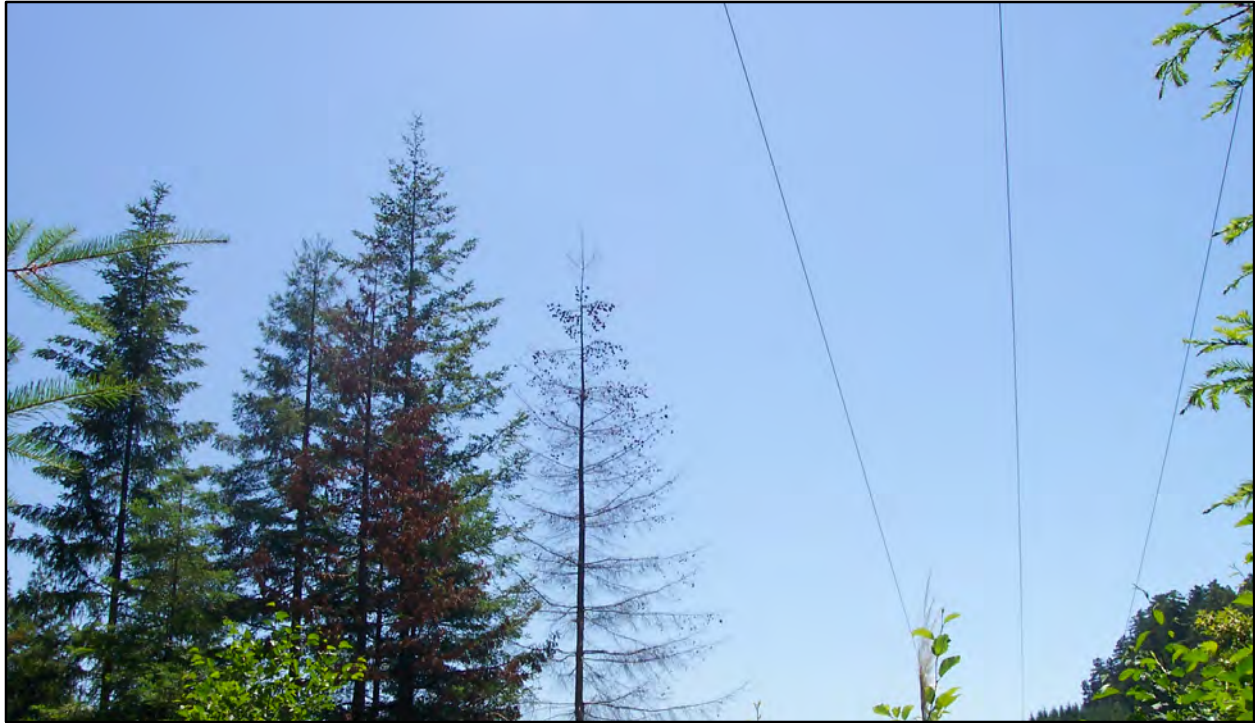
Photograph 13: Looking south from pole 5/18. Note dead tree to left of power line creating an imminent hazard.

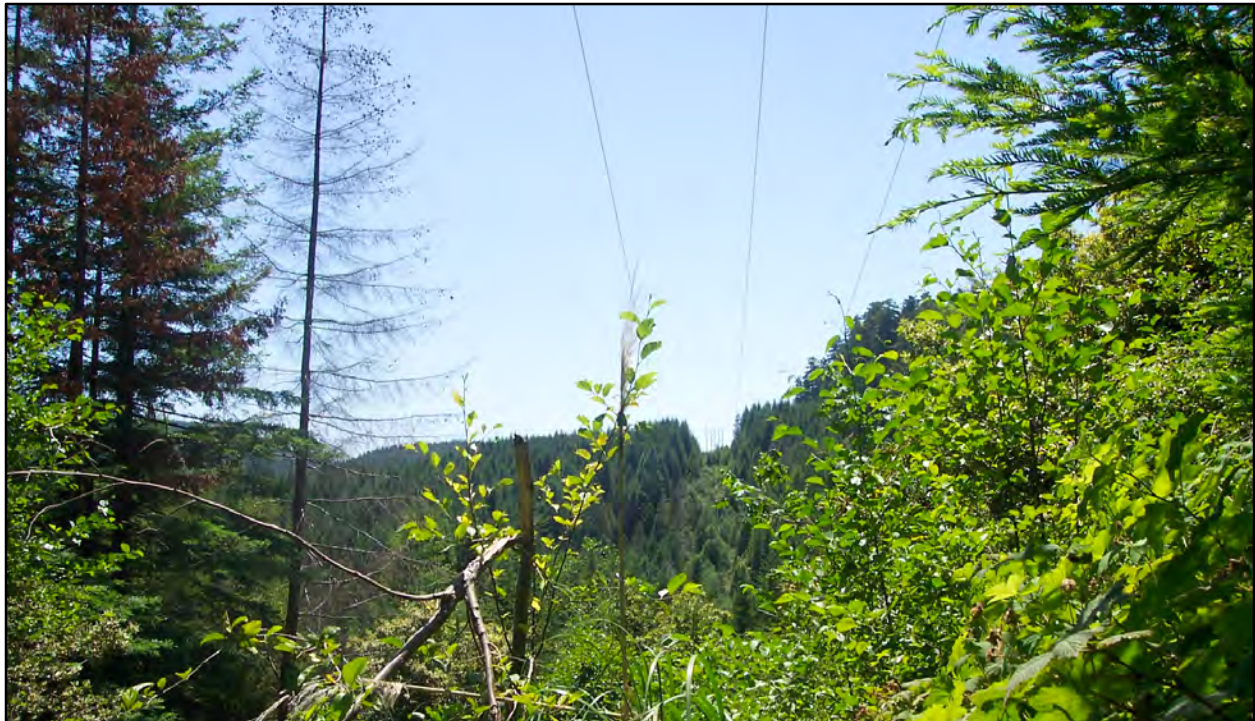
Photograph 14: Looking south from pole 5/18. Note dead tree to left of power line creating an imminent hazard.

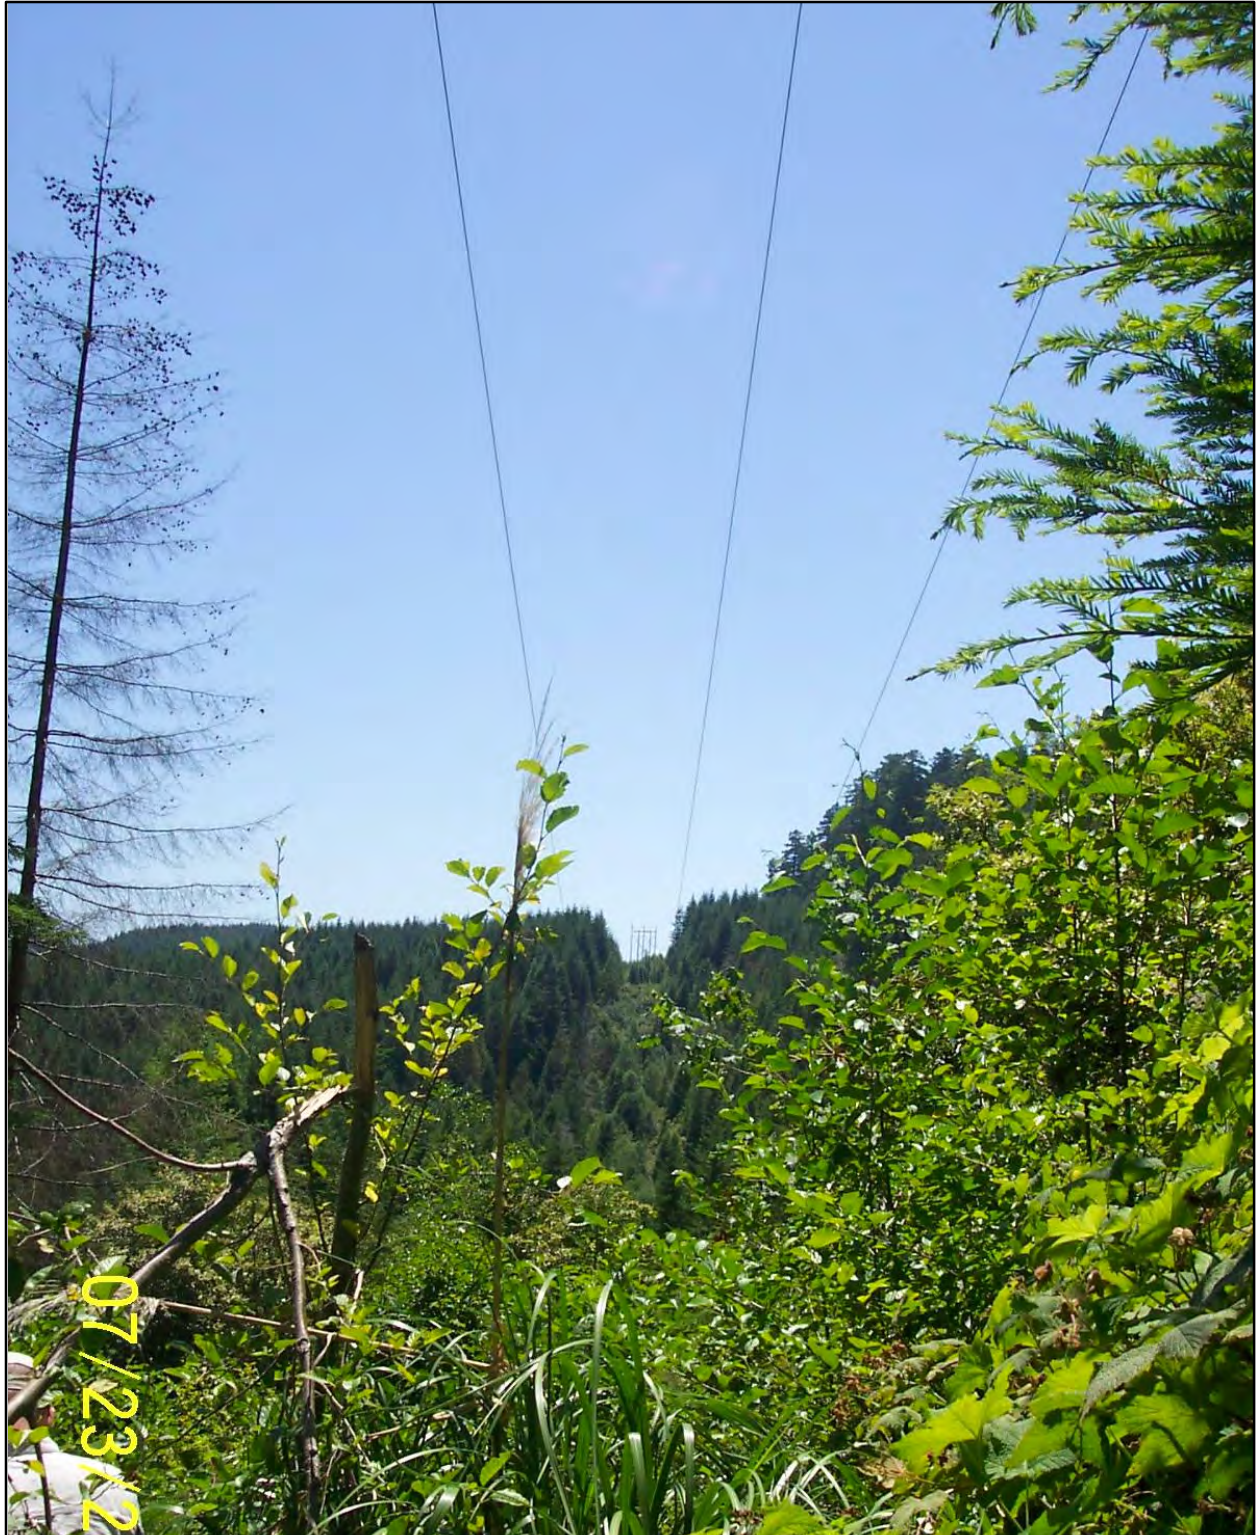
Photograph 15: Looking south from pole 5/18. Note dead tree to left of power line creating an imminent hazard.

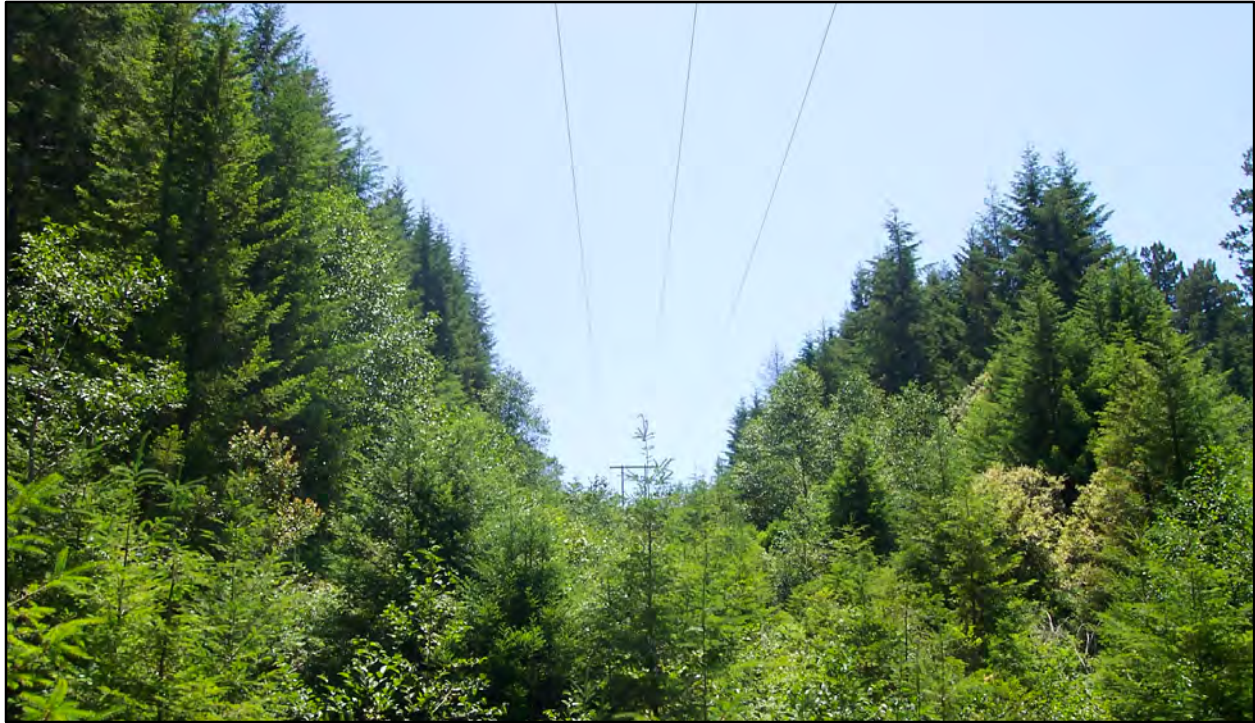
Photograph 16: Pole 2/19. Shrubs provide good cover and do not threaten the line. Taller growing coniferous trees will be removed periodically.
